# HEATEC TEC-NOTE

Publication No. 6-04-125

## STRAINERS AFFECT ASPHALT PUMP LIFE

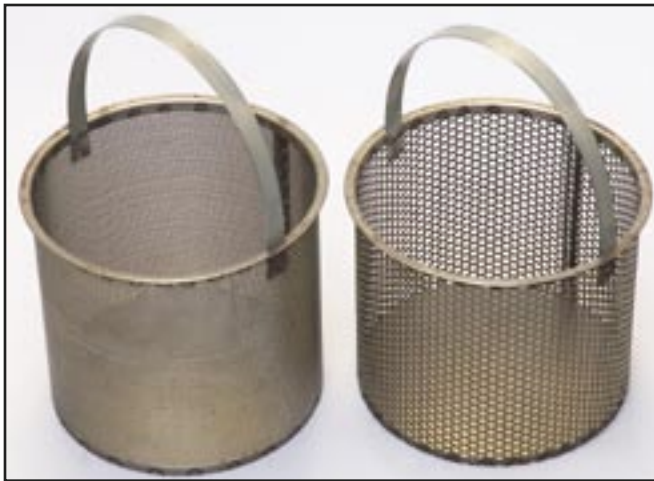
Heatec makes two sizes of strainers: a fine and a coarse (**Figure 1**). The coarse strainer has 1/4-inch openings. The fine strainer has 5/64-inch openings. We currently provide the fine strainer as standard unless our customer specifically requests coarse strainers instead. We *do not* recommend the coarse strainer for normal use.

Figure 1. Left: fine strainer. Right: coarse strainer

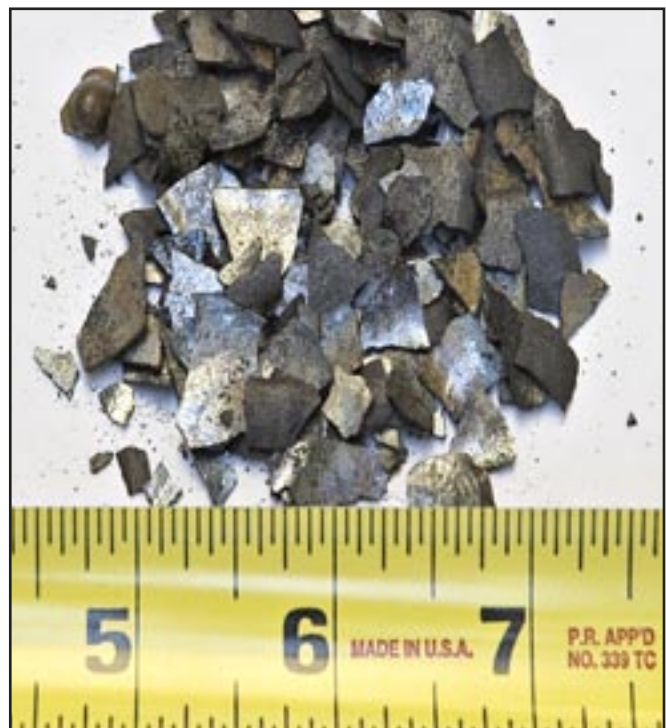
When you use coarse strainers you put your asphalt pumps at risk. In the worse case, debris that can pass through the 1/4-inch openings in the strainers (**Figure 2**) may immediately damage your pumps (**Figure 3**). In any case, the life of your pumps will be shortened significantly.

Figure 2. Debris that might pass through a coarse strainer.

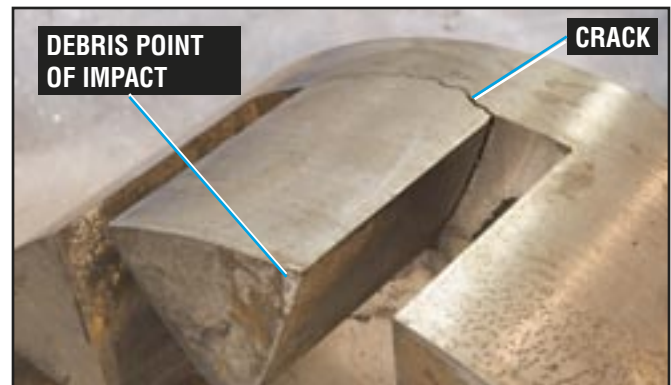
Figure 3. This pump failed from debris caught in its rotor.

The warranty on Viking pumps limits the size of the openings in the strainer to 10 mesh or 0.075-inch. This is comparable to the openings in our fine strainer. Consequently, if you choose to use a strainer with openings of a larger size, Viking is not obligated to cover the pump under warranty.
